Advisory Region Bridger Range Longitude -110.98W Latitude 45.92N **Avalanche Details:** <u>New snow avalanches, Frazier Basin</u> **Forecast link:** <u>GNFAC Avalanche Forecast for Tue Mar 21, 2023GNFAC Avalanche Forecast for Wed Mar</u> 22, 2023GNFAC Avalanche Forecast for Thu Mar 23, 2023 Bridger Range, 2023-03-20

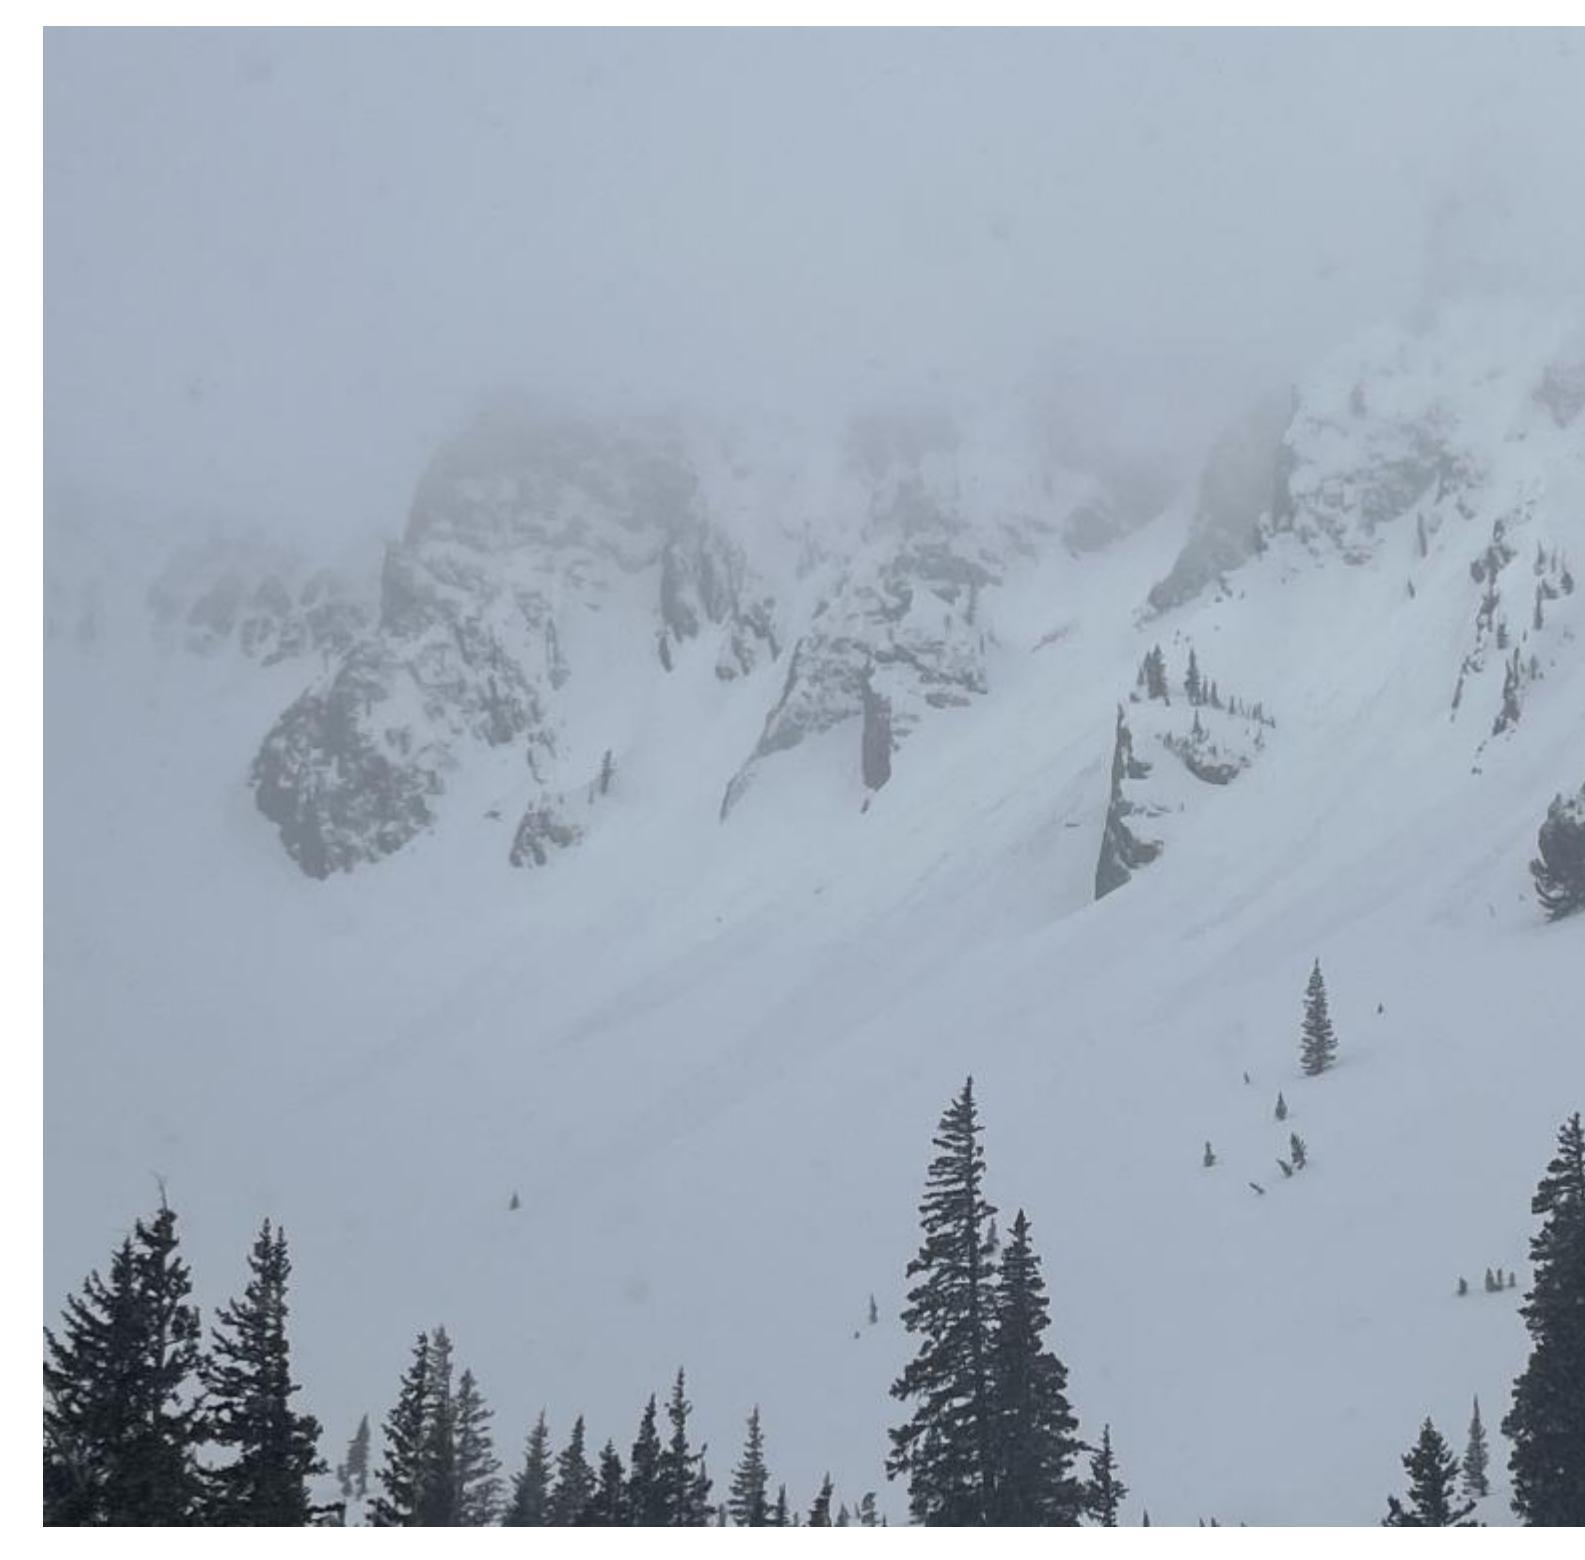
As we returned to Frazier Basin from below, we saw five natural avalanches on the southeast-facing wall of the basin. They entrained only the 1 to 2 inches of snow that had fallen during the day. However, they were notable in that they ran 500 to 700 vertical feet. They indicate that the new snow may not bond well to the old snow surface. A crust formed by the recent warm temperatures and sunny skies is the subsurface that snow is falling on. This will become a more significant concern as more snow falls this week. Photo: GNFAC
